# 9.7 Wetlands Report

## **PIERCE COLLEGE – PUYALLUP CAMPUS REVISED WETLAND RECONNAISSANCE AND VERIFICATION REPORT**

**GRETTE ASSOCIATES<sup>LLC</sup>**  
2111 NORTH 30<sup>TH</sup>  
TACOMA, WASHINGTON 98403  
(253) 573-9300

NOVEMBER 13, 2006

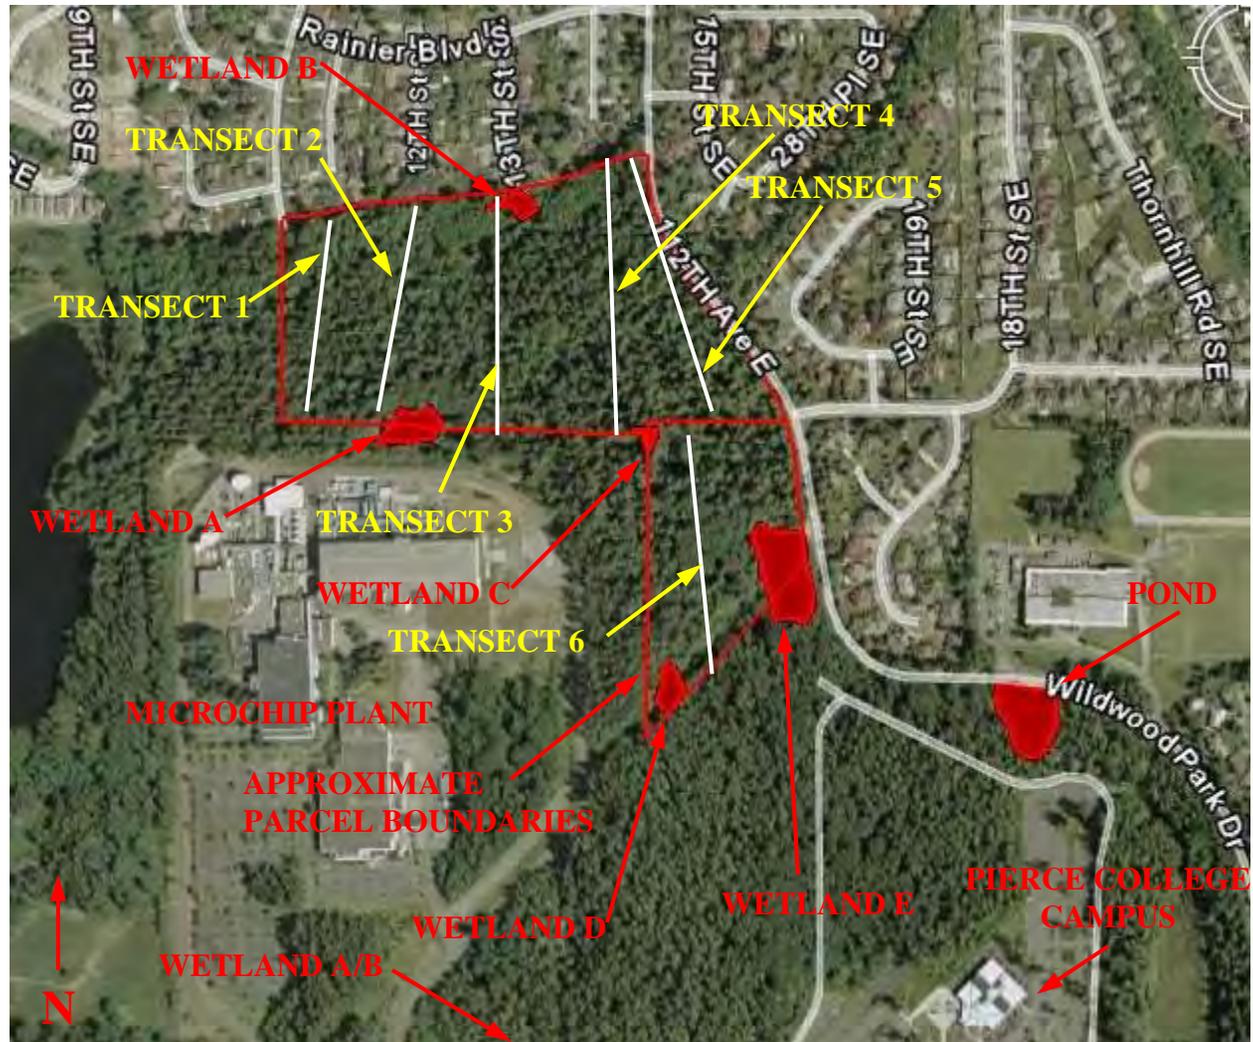
Figure 1. Wetland Reconnaissance Map

Grette Associates staff biologists visited the site on April 25, 2006 and conducted a transect survey of the site. The purpose of the investigation was to verify the presence and boundaries of previously delineated wetlands and to document any unidentified wetland areas. The wetlands encountered were not delineated according to US Army Corps of Engineers and Ecology standard methods. Wetland biologists used site topography, vegetation, hydrology, and soils to determine coarse boundaries which were flagged and surveyed during the investigations using a Trimble Pro-XR Differential Global Positioning System (dGPS) unit, as were transect endpoints (Figure 1).

The access road along the 31<sup>st</sup> Ave S alignment was used as a baseline for six north-south transects; five of which were to the north of the access road (transects 1-5) and one of which was south of the it (transect 6). The transects were spaced roughly 300- to 400-ft apart (Figure 1). The biologists walked each transect together looking for indicators of wetland areas based on vegetation, hydrology, and topographic features. When draws or other features were observed from transects, they were followed off of the transects to determine whether they supported wetland areas.

Wetland A is a large wetland area that had been previously delineated as Wetland A/B (Entranco 2003) was flagged adjacent to the access road between transects 1 and 2 (Figure 1). The verification generally agrees with the flagging from the previous delineation. Wetland A is approximately 14,763 square feet in size, and is classified as a Palustrine Scrub-Shrub, Seasonally Flooded wetland. Around the margins the canopy included red alder, pacific dogwood, black cottonwood, and western red cedar; but the majority of the wetland area was shrub-scrub vegetation including red-osier dogwood and salmonberry.

Wetland B is the only wetland area that was not either previously flagged or delineated. It is located at the sloping south end of transect 3 adjacent to residential development and the street end for 13<sup>th</sup> Street SE, and is approximately 5,058 square feet (Figure 1). Wetland B is classified as a Palustrine Forested/Emergent, Seasonally Flooded wetland. The canopy on the hillside is primarily red alder with a grassy understory; there are also large black cottonwoods and Himalayan blackberry along the edges of the wetland near the street.

Wetland C is located at the northeast corner of the fenceline between the Pierce College property and the adjacent property (Figure 1). Wetland C is classified as a Palustrine Forested/Scrub-Shrub, Seasonally Flooded wetland. There was previous wetland flagging at this site, but it does not appear to correspond to any Entranco delineation reports. Wetland C is approximately 2,365 square feet, which includes part of the access road/walking path. Vegetation is mostly mixed shrub, ferns, and emergent ground cover with a few red alder and western red cedar. Shrubs include salmonberry and red elderberry, ferns include sword fern and bracken fern, and emergent ground cover includes slough sedge, reed canary grass, and creeping buttercup.

Wetland D is located at the south end of transect 6 (Figure 1). It spans the pipeline right of way and includes forested and shrub-scrub assemblages on either side of it. The portion of Wetland D within the study area (north of the pipeline right-of-way) is approximately 9,774 square feet in size. Wetland D is classified as a Palustrine Forested, Seasonally Flooded wetland. The portion of the wetland south of the right-of-way was investigated to gauge the accuracy of the previous delineation. The verification generally agrees with the flagging from the previous delineation in this area. The areas immediately on either side of the right of way include a red alder and big leaf maple canopy with understory dominated by red-osier dogwood, slough sedge, salmonberry and sparse common rush, which is more common at the far south end of the wetland. The right of way appears to undergo regular vegetation maintenance and is dominated by reed canary grass. There are a number of large snags at the far south end of the wetland near the parking lot retaining wall.

Wetland E is located at the east edge of the property adjacent to Wildwood Park Drive (Figure 1). It also extends to either side of the pipeline right of way and is approximately 38,870 square feet in size. The area south of the right of way was previously delineated as Wetland C (Entranco 2001). The verification generally agrees with flagging from the previous delineation in this area. The species composition is similar to Wetland D,

An existing pond is located immediately south of Wildwood Park Drive, southeast of the primary study area for this investigation (Figure 1). The pond is located opposite Wildwood Park Drive from the entrance to Ferrucci Junior High School, and is approximately 35,616 square feet in size (Entranco 2002).

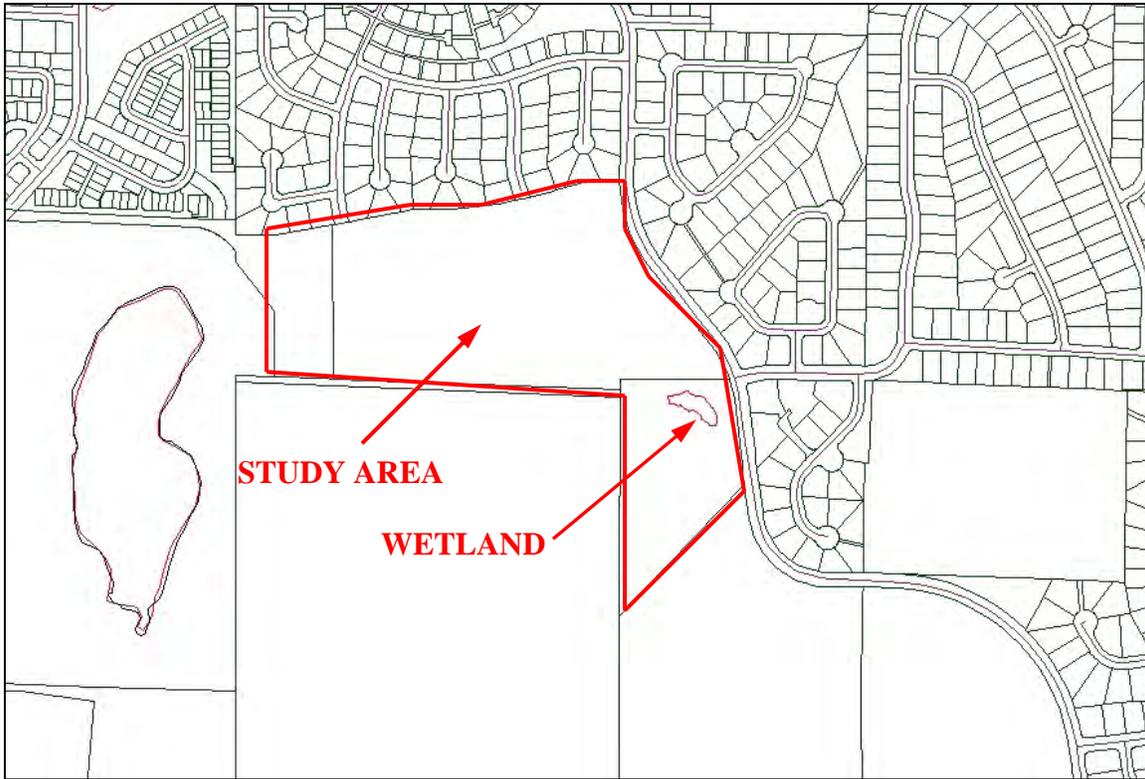
**Figure 6. Pierce County Wetland Inventory map**

Prior to the field investigations, several public resources were consulted to determine if previously identified wetlands exist on the site. These resources include the Natural Resource Conservation Service's (NRCS) Soil Survey of Pierce County, Washington, the U. S. Fish and Wildlife Service's (USFWS) National Wetland Inventory (NWI), and Pierce County's County Wetland Inventory (CWI). The information gathered from these resources is described below.
