Environmental Analysis

8.1 Introduction

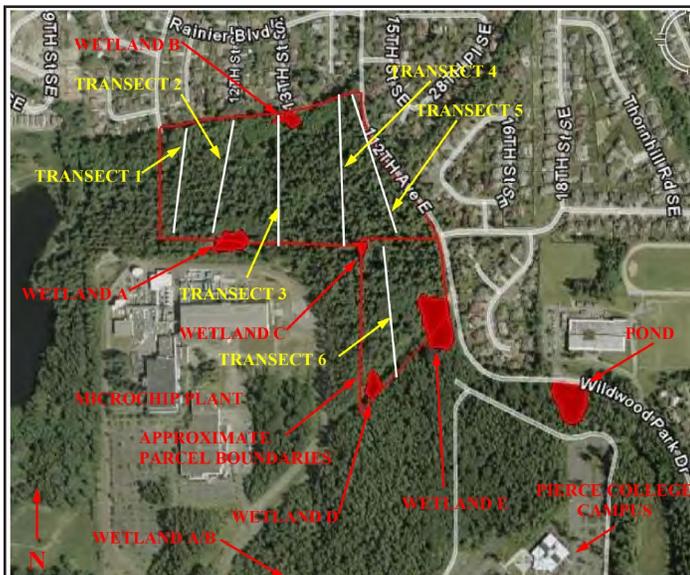
Figure 8.1 Wetland Reconnaissance Map

Grette Associates conducted a wetland reconnaissance of approximately 43.79 acres in the northwest portion of the project site, to verify the presence and boundaries of previously delineated wetlands and to document unidentified wetland areas in the northern portion of the site. Wetland biologists used site topography, vegetation, hydrology and soils to determine course boundaries. A copy of the Wetland Reconnaissance and Verification Report can be found in Appendix 9.7 Wetlands Report.

Wetland B has not been previously flagged or delineated and is located in the sloping south end of transect 3 (per Figure 8.1) adjacent to residential development and the street end of 13th Street SE. The wetland is approximately 5,058 square feet in size and is classified as Category III, Palustrine Forested/Emergent, Seasonally Flooded Wetland. The water quality functions provided by Wetland B are fairly limited due to its small size and lack of hydrologic connection to other waters.

Wetland D is located at the south end of Transect 6 (per Figure 8.1) and spans the pipeline right-of way and totals approximately 35,233 square feet. It is classified as a Palustrine Forested, Seasonally Flooded Wetland. There is dense vegetation surrounding the wetland which provides habitat for wildlife. Water quality functions provided by the wetland include toxin removal, sediment trapping and erosion control. Wetland D also provides a high degree of organic productivity due to its dense vegetation in addition for provision for wildlife habitat.
